# **U.S.S. TEXAS (BB-35)**

## **OPTION 5 TANK INSPECTION AND REPAIR ASSESSMENT**

Vessel Survey Report No. 2443

Vessel surveyed: U.S.S. TEXAS (BB-35)

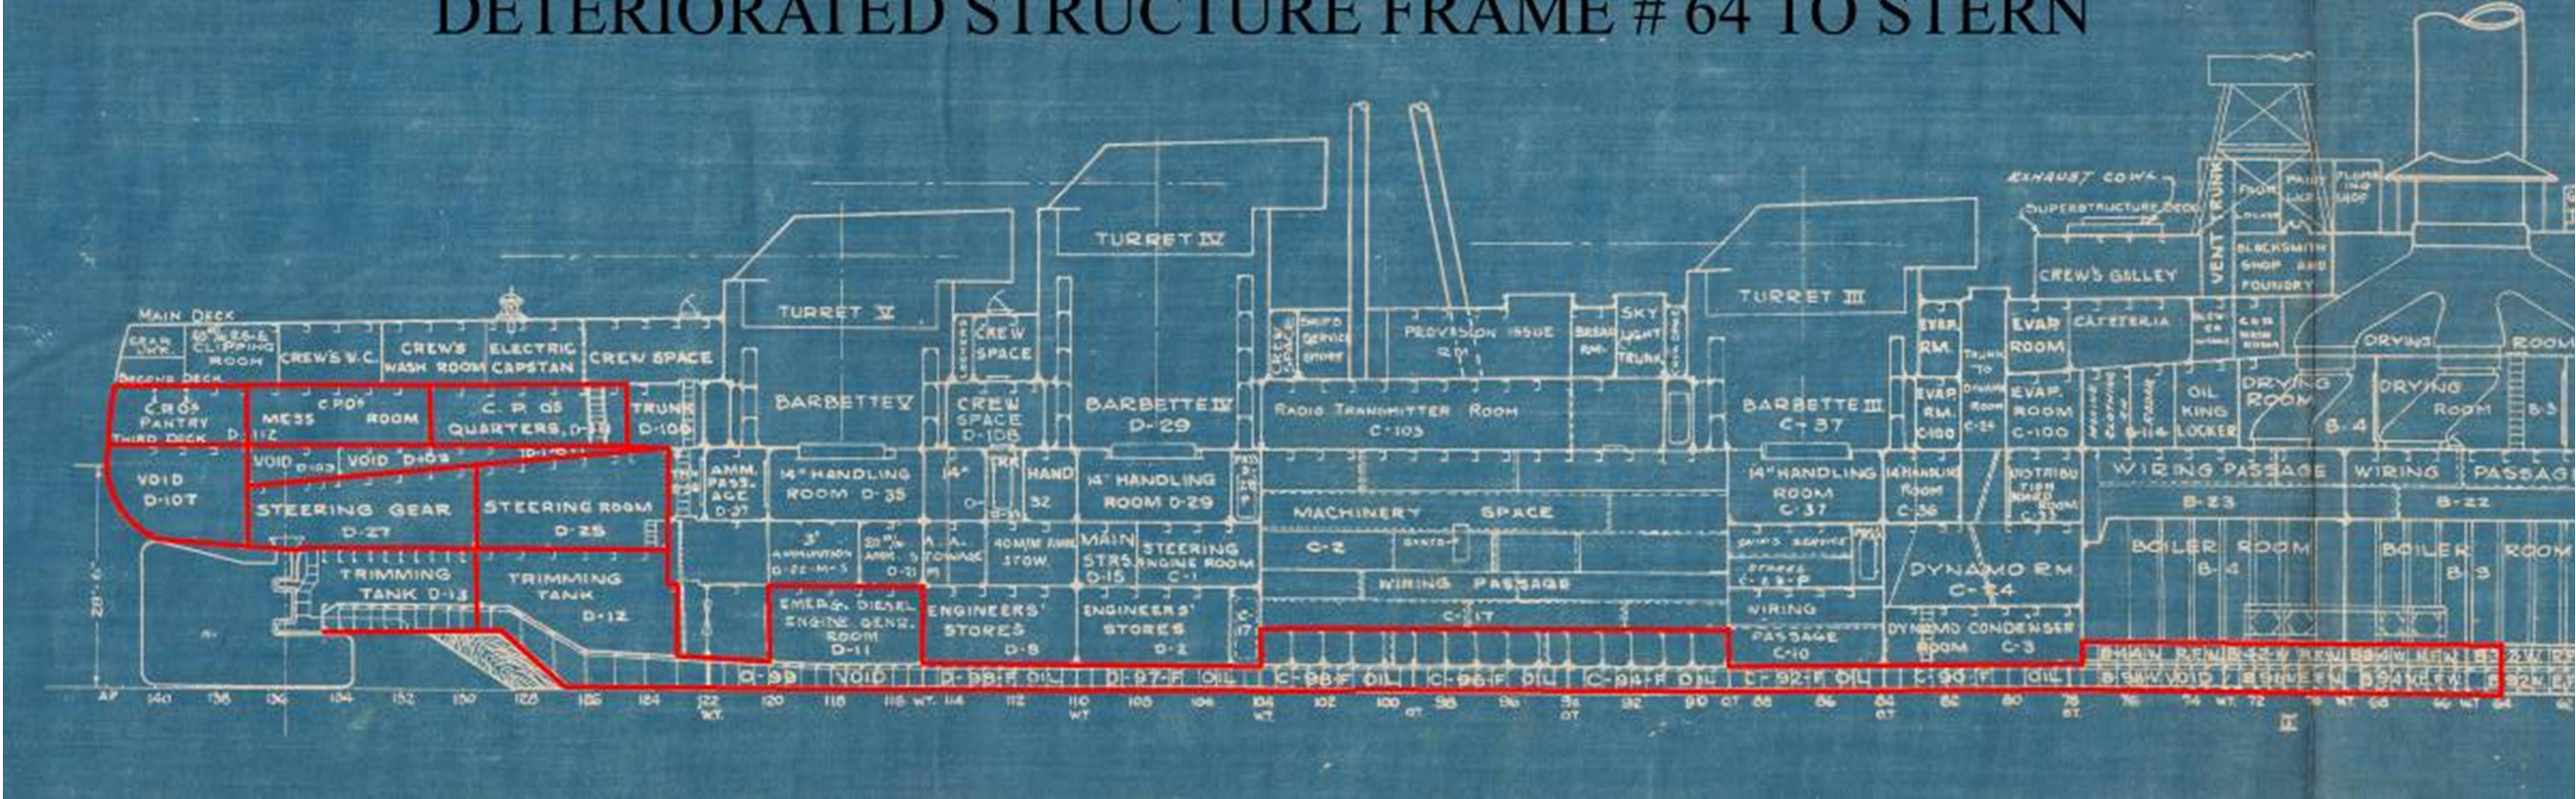
U.S.S. TEXAS (BB-35)  
DETERIORATED STRUCTURE FRAME # 64 TO STERN

Figure 1: Structurally Deficient and Critical Areas of Vessel (Demarcated Within Red Lines)

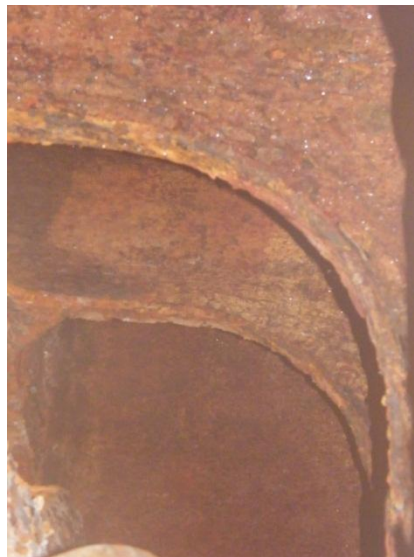
Stem aprons heavily corroded at 30 - 40% loss of structural integrity. Transverse framing showing 30%+ loss of integrity. Aft bulkhead intact. No evidence of leakage.

Figure 3: Stem Aprons, Looking Down in A-41.

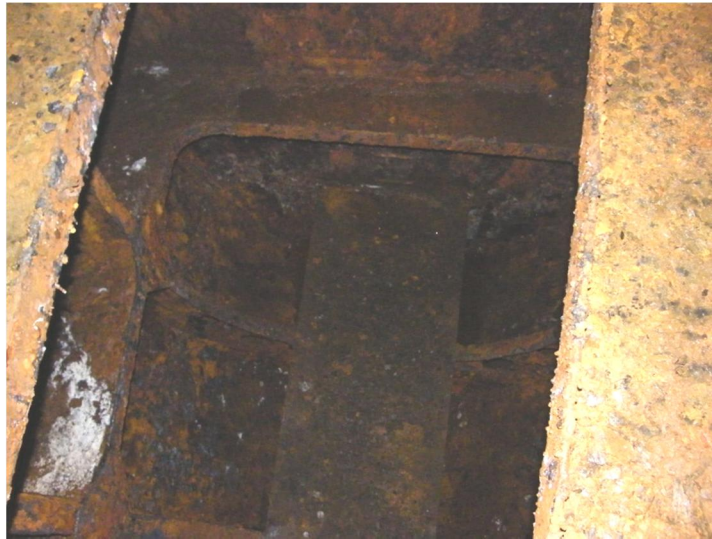
Stem aprons heavily corroded at 50%+ loss of structural integrity. Upper transverse framing showing 30%+ loss of integrity; lower transverse framing showing 40%+ loss of integrity. Aft bulkhead intact with 30-40% wastage. Keel showing 30 – 40% wastage in areas, but intact. Standing water 2-3” with heavy muck/rust/scale present. Condensation standing on horizontal aprons and shelves causing heavy corrosion.

**Figure 4: Keel and Bilges at Forward End of A-41**

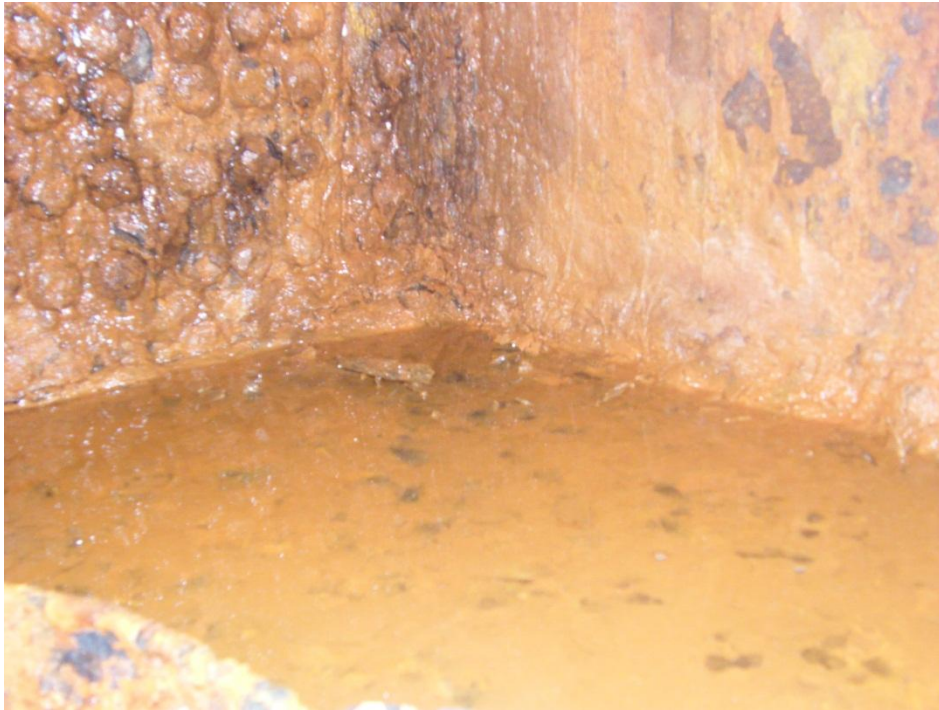
Figure 6: Standing Water on Side Shell Aprons Due to Condensation in A-41

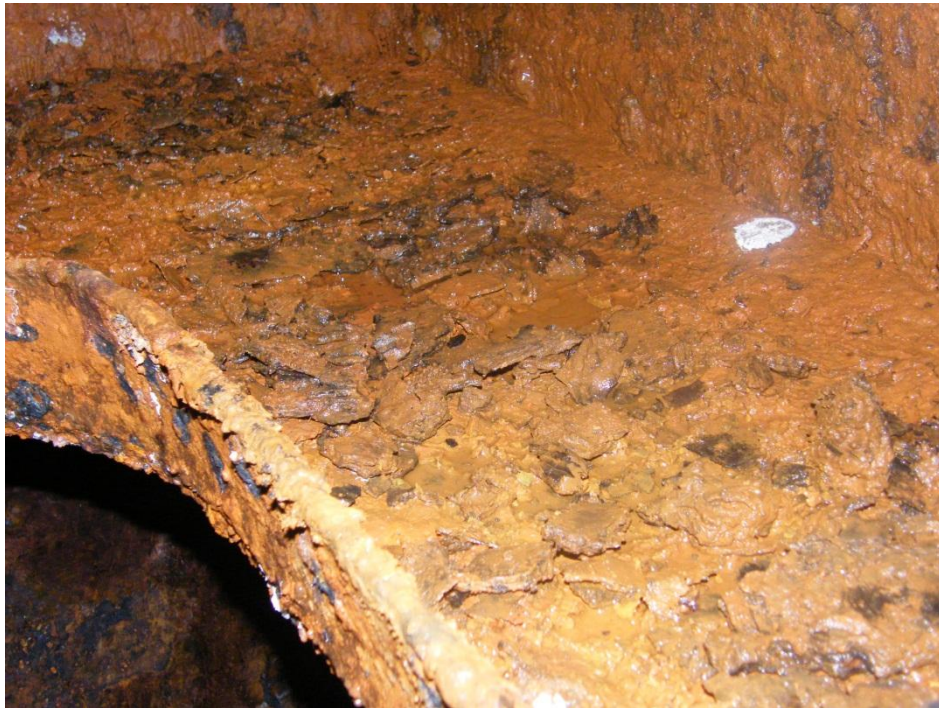
Figure 7: Heavy Rust/scale, and Condensation on Side Shell Apron in A-41

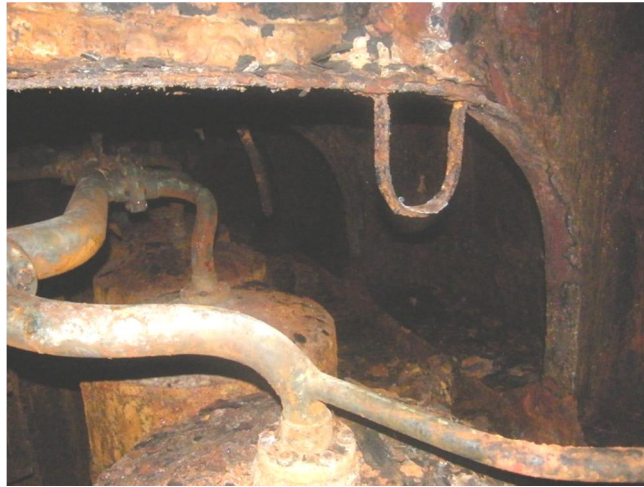
Side shell aprons heavily corroded at 50%+ loss of structural integrity. Upper transverse framing showing 30%+ loss of integrity; lower transverse framing showing 40%+ loss of integrity. Aft bulkhead intact with 30-40% wastage. Keel showing 30–40% wastage in areas, but intact. Standing water 2-3" with heavy muck/rust/scale present. Condensation standing on horizontal aprons and shelves causing heavy corrosion.

Figure 8: Top of Gasoline Storage Tanks within A-2

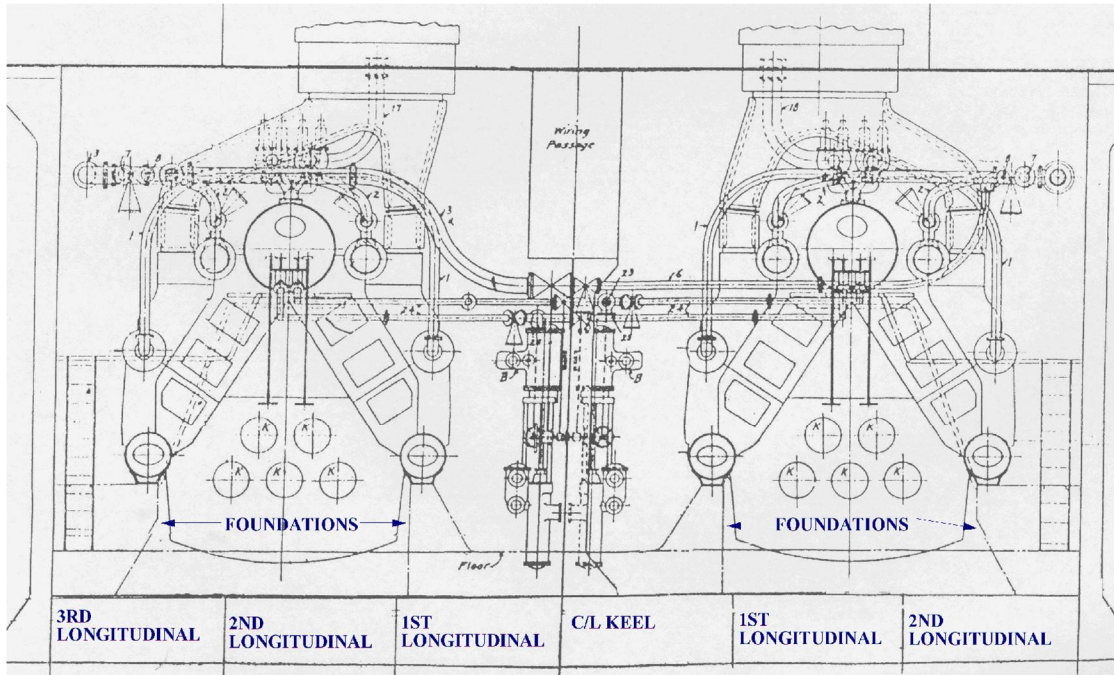
Figure 10: Frontal View of Boilers in B-2 Fireroom, Looking Aft

Material condition of both boilers show them to be in good repair. Bases of both boiler units are intact with structural foundations in good repair with no repairs required. The main floor over the Hold Tankage is intact with no repairs required. Bulkheads and vertical supports intact and in good condition.

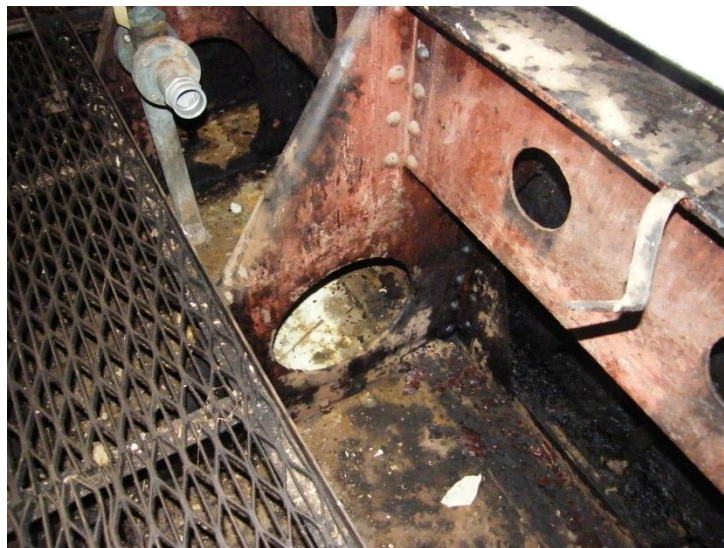
Figure 11: Base Foundation and Intact Floor of Port Side Boiler in B-2 Fireroom

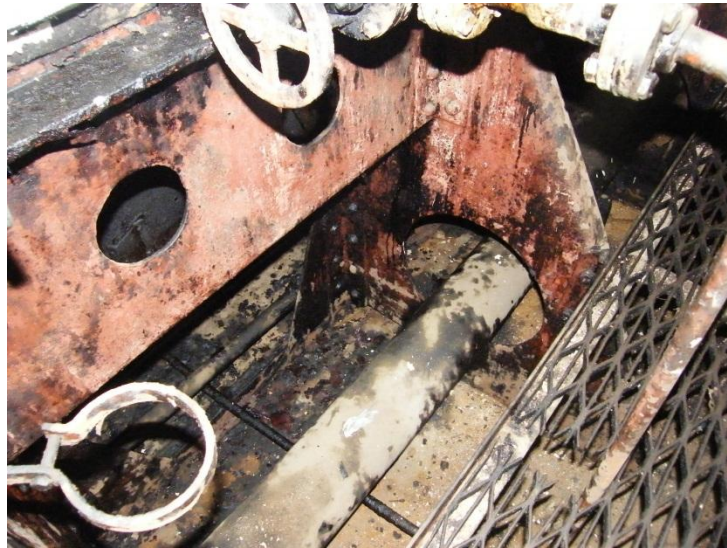
Figure 12: Base Foundation and Intact Floor of Starboard Side Boiler in B-2 Fireroom

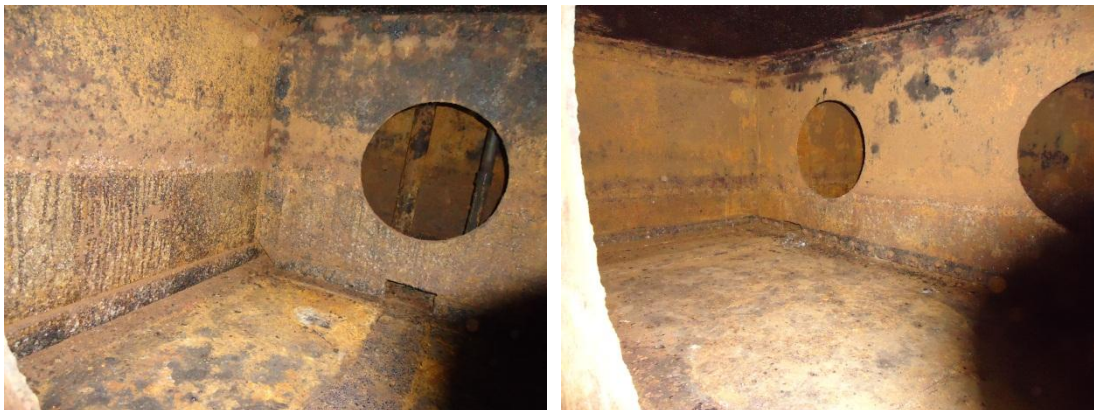
Not previously inspected under the Option 1 Survey, this tank space with three transverse frames and two longitudinal frames is directly under boiler room fuel manifolds and miscellaneous equipment; tank components are in good structural condition with no repairs required at this time. Both transverse and longitudinal support frames are intact with minimal plate loss of 20 – 40% with minimal deflection of steel plate. The floor of this tankage is heavily rusted/scaled, but with no standing water present. Forward bulkhead intact showing 20 - 30% plate loss and the aft bulkhead intact with 30-40% plate loss with rust/scale present. Vertical scantlings on both fore and aft and outboard bulkheads intact. Centerline keel plate shows plate loss of 20-40% in spots, but is not in need of repair at this time. Evidence of previous long term standing water.

Figure 13: B-2-2-W. Views of Tank Showing Relatively Good Structural Condition of Scantlings

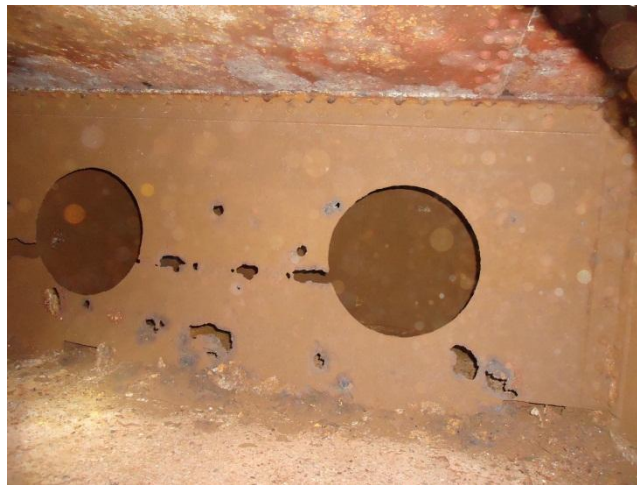
Not previously inspected under the Option 1 Survey, this tank space with three transverse frames and two longitudinal frames is directly under both boiler room fuel manifolds and miscellaneous components; tank components are in good structural condition with no repairs required at this time. Both transverse and longitudinal support frames are intact with plate loss in areas averaging 20 – 40% with minimal deflection of steel plate. The transverse and longitudinal frames in this compartment have areas of ‘swiss cheese’ (holed plating); it is not considered a threat for the immediate period (10 -15 years) given the structural condition of adjacent scantlings, the strength of the floor above and the foundations for the boilers. The floor of this tankage is heavily rusted/scaled with greater than 30 - 50% wastage, but with no standing water present. Forward bulkhead intact showing 30 - 40% plate loss and the aft bulkhead intact with 30-40% plate loss with rust/scale present. Vertical scantlings on both fore and aft and outboard bulkheads intact. Centerline keel plate shows plate loss of 50% in areas of deep pitting, but is not in need of repair at this time.

Figure 14: B-2-1-W. Holed Transverse Frame within Tank

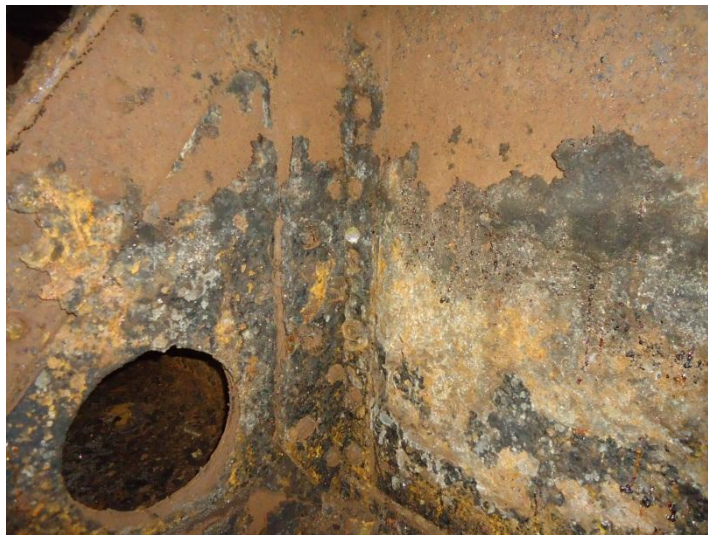
Not previously inspected under the Option 1 Survey, this tank space with four transverse frames and two longitudinal frames is directly under the port boiler; tank components are in good structural condition with no repairs required at this time. Both transverse and longitudinal support frames are intact with plate loss in areas averaging 30 – 50% with minimal deflection of steel plate. Wastage of the boiler foundation is 40 – 60%. The floor of this tankage is heavily rusted/scaled with greater than 30 - 50% wastage, but with no standing water present. Forward bulkhead intact showing 30 - 40% plate loss and the aft bulkhead intact with 30 - 40% plate loss with rust/scale present. Vertical scantlings on both fore and aft and outboard bulkheads intact. Centerline keel plate shows plate loss of 50% with keelson knees showing 50 – 70% loss in areas of deep pitting, but is not in need of repair at this time.

Figure 16: B-2-4-W. Boiler Foundation Knee with Longitudinal Frame

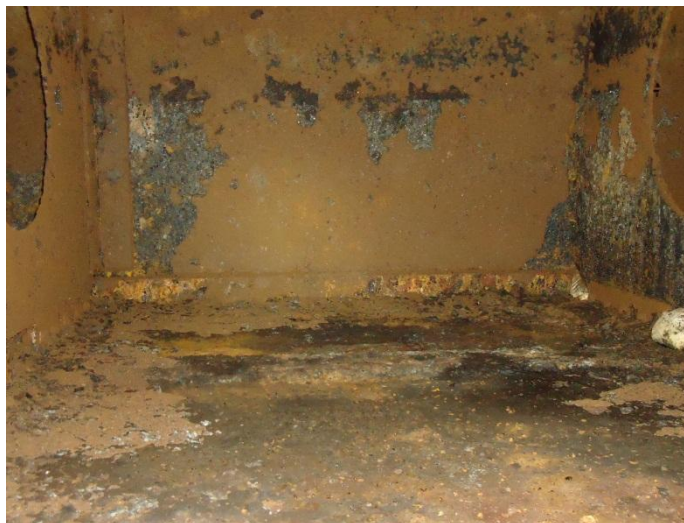
Figure 17: B-2-4-W. Typical Longitudinal Frame within Tank

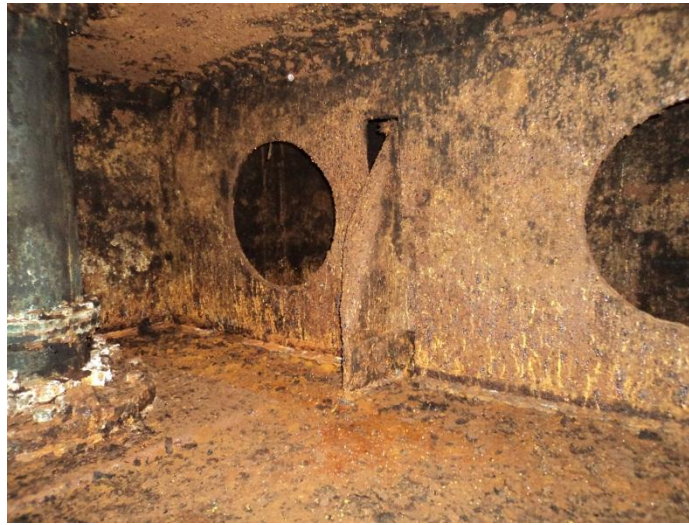
Not previously inspected under the Option 1 Survey, this tank space with four transverse frames and two longitudinal frames is directly under the starboard boiler; tank components are in fair - good structural condition with no repairs required at this time. Both transverse and longitudinal support frames are intact with plate loss in areas averaging 30 – 60% with minimal deflection of steel plate; steel plate delaminating on both sides equally. The floor of this tankage is heavily rusted/scaled with greater than 30 - 50% wastage, but with no standing water present. Forward bulkhead intact showing 30 - 40% plate loss and the aft bulkhead intact with 30 - 40% plate loss with rust/scale present. Vertical scantlings on both fore and aft and outboard bulkheads intact. Centerline keel plate shows plate loss of 50% in areas of deep pitting with knees showing 50%+ loss in aft area of tank, but is not in need of repair at this time.

Figure 18: B-2-3-W. Typical Longitudinal Frame within Tank, Showing Boiler Foundation

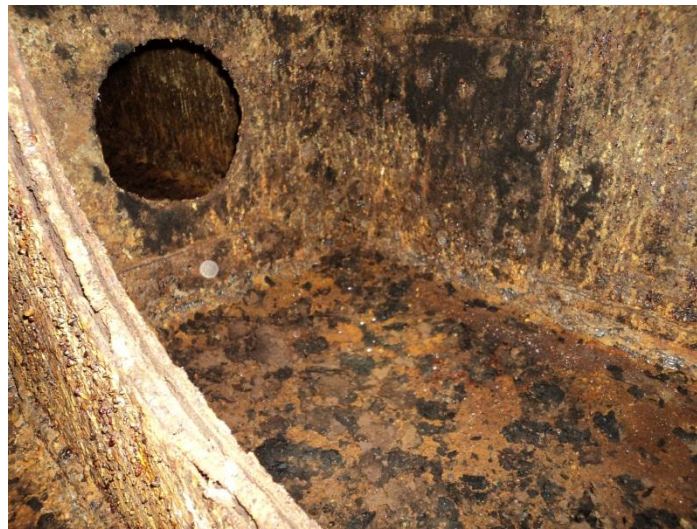
Figure 19: B-2-3-W. Delaminated Steel Scantling, Typical for Most Frames within this Tank

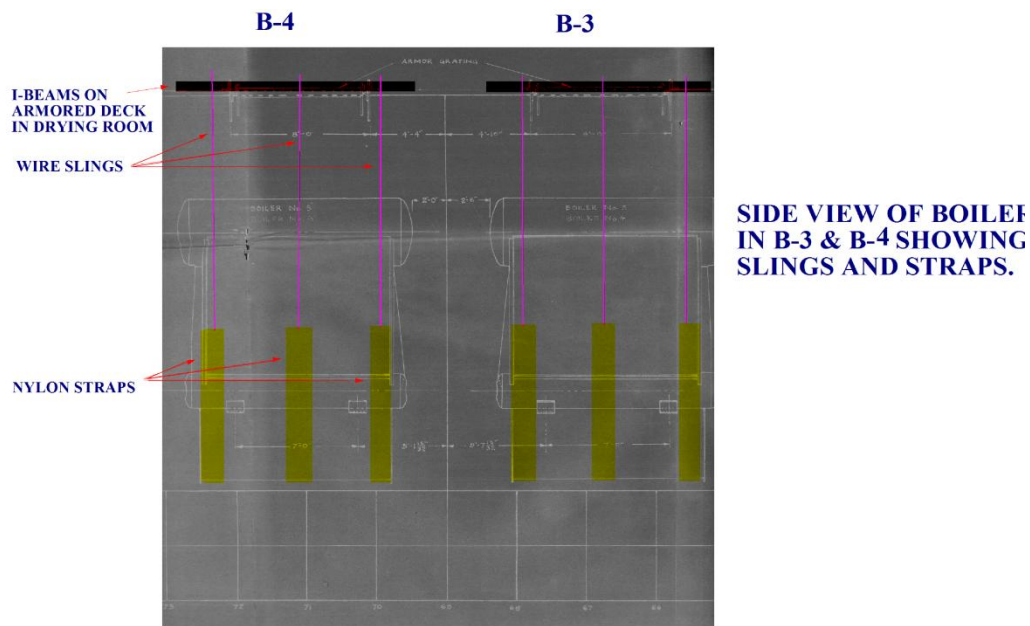
**Figure 21: View of Sides of Boilers showing I-beams, Wire and Nylon Straps for B-3 & B-4 Firerooms**

The condition of both boiler room floors and the condition of support frames within the Hold Tankage beneath the boilers mandates that support of the pair of boilers each in B-3 and B-4 Firerooms; this becomes necessary while the floors and Hold Tankage are rebuilt. The support for the boilers can be achieved by suspending them from the armor deck above. A possible approach would be to utilize steel cable fastened to three 24" wide x 30' long double, 2 ply nylon straps per boiler (for supporting the underneath of the boilers) thence to the overhead deck where sistered 10 x 60 I-beams could rest on the deck with 1.25 x 7 threaded rod attached to the cable ends. The cable ends would be attached to 1.25" bright wire, uncoated, fiber core (FC) wire rope improved plow steel (IPC) with a breaking load of 129,200 lbs down to the nylon straps. The threaded rod could be tensioned to just take the load of the boiler off of the sub-structure allowing repairs to be made in safety. It is estimated that using hardware of this size would result in a safety factor of four (4) and could be tested with dial indicators for working loads; anticipate three straps per boiler. Section 106 remediation to put this back to original would require removal of the support gear and welding the circular holes in the armor deck back to original.

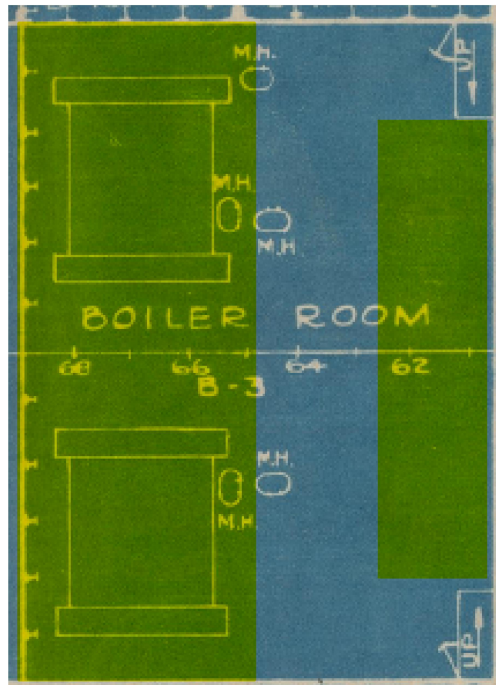
Figure 22: Shaded Area in Yellow within B-3 Signifying Areas where Floors Need Replacement

Once the tankage below has been repaired, the deck can be repair/replaced as needed. Each Boiler Room has approximately 1,632 square feet of floor space. B-3 Boiler Room will require 800 square feet of new ½" A-36 mild steel deck plating, primarily under both boilers and in other scattered areas of the space. B-4 Boiler Room will require 800 square feet of new ½" A-36 mild steel deck plating, primarily under both boilers and in other scattered areas of the space.

Crop out and replace 1,600 sq. ft of ½" A-36 steel deck plate as needed.

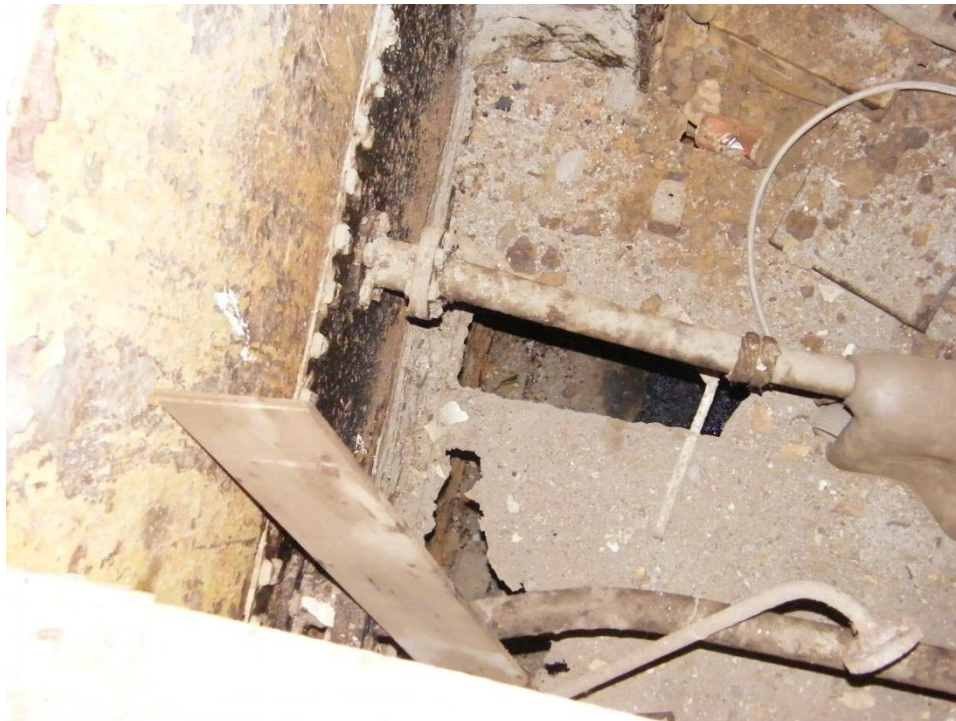
Figure 23: Wasted Floor Under Rear of Port Side Boiler in B-3

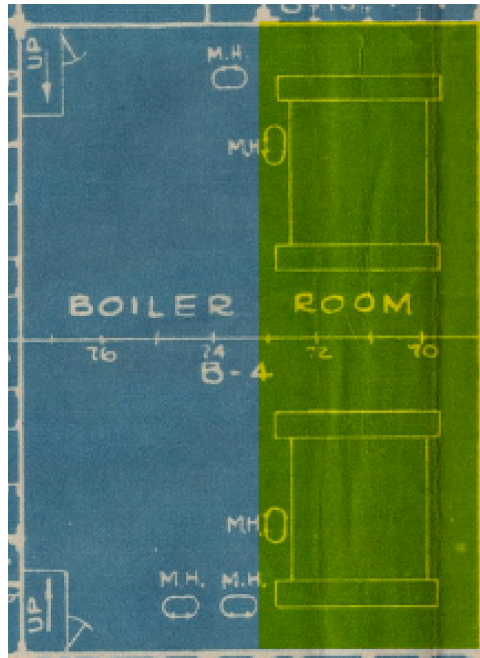
Figure 24: Shaded Area in Yellow within B-4 Signifying Areas where Floors Need Replacement

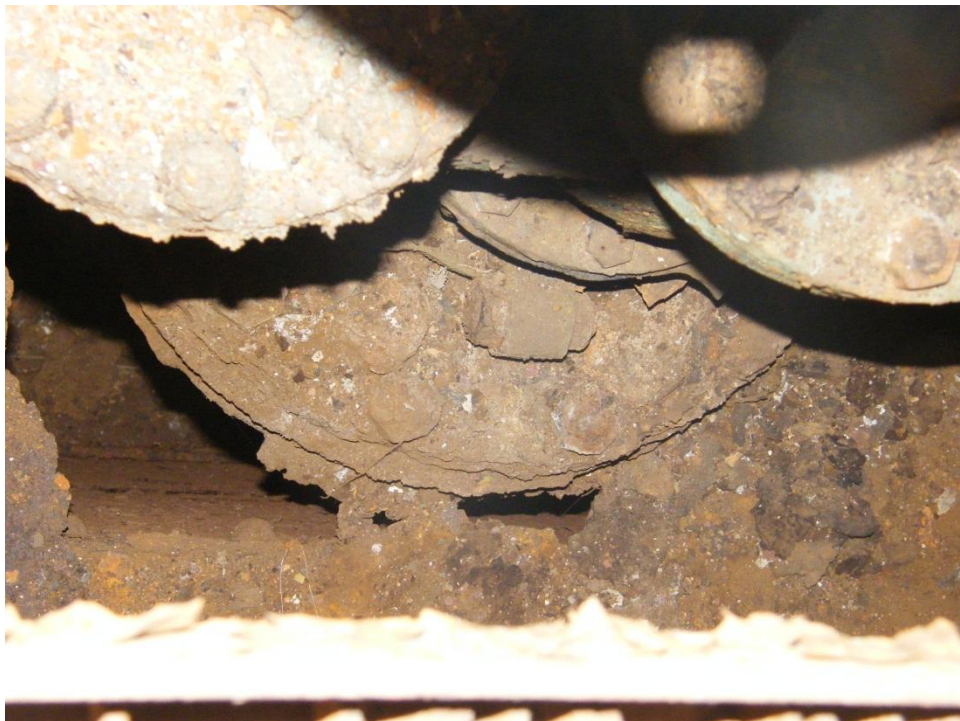
Figure 25: Wasted Floor Under Rear of Port Side Boiler in B-4

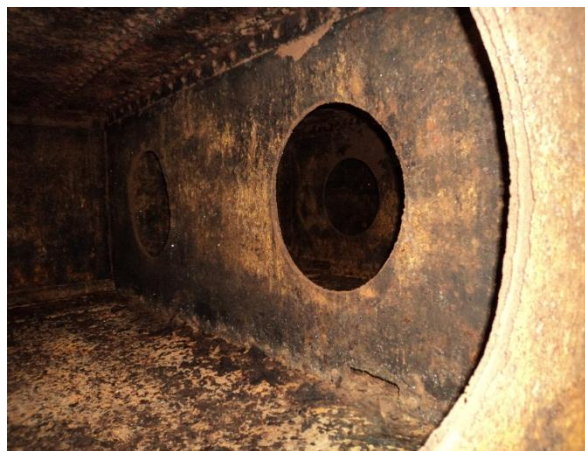
Not previously inspected under the Option 1 Survey, this tank space with four transverse frames and two longitudinal frames is directly under both boiler room fuel manifolds and miscellaneous components; tank components are in fair/good structural condition with no repairs required at this time. Both transverse and longitudinal support frames are intact with plate loss in areas averaging 40 – 50%; transverses deflected 1”+. The floor of this tankage is heavily rusted/scaled with greater than 30 - 50% wastage. Forward bulkhead intact showing 30 - 40% plate loss and the aft bulkhead intact with 40- 50% plate loss with heavy rust/scale present. Vertical scantlings on both fore and aft and outboard bulkheads intact. Centerline keel plate shows plate loss of 50% in areas of deep pitting, but is not in need of repair at this time. Compartment is dry.

Figure 27: Typical Condition within B-3-2-W Tank

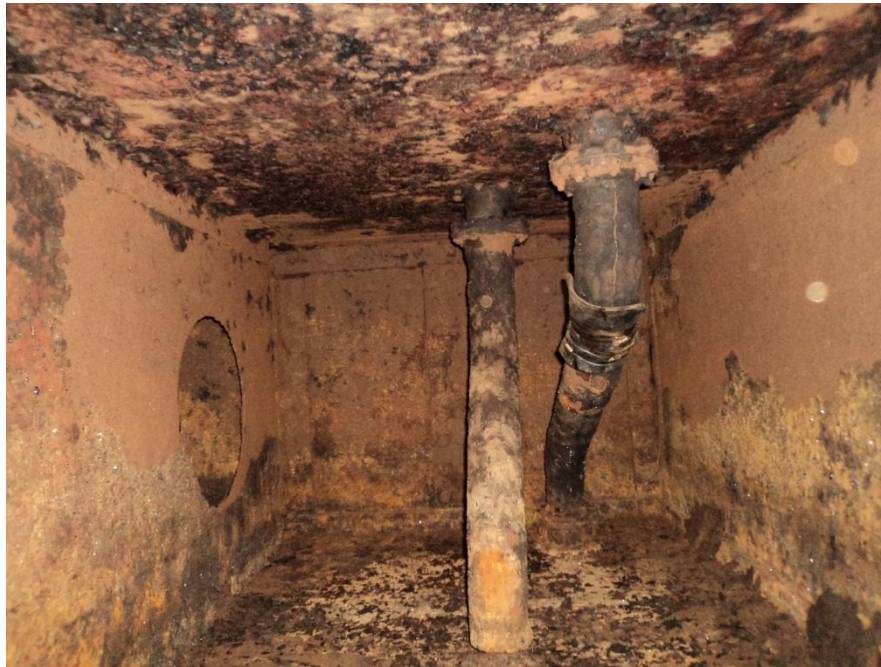
Figure 28: Typical Condition within B-3-2-W Tank

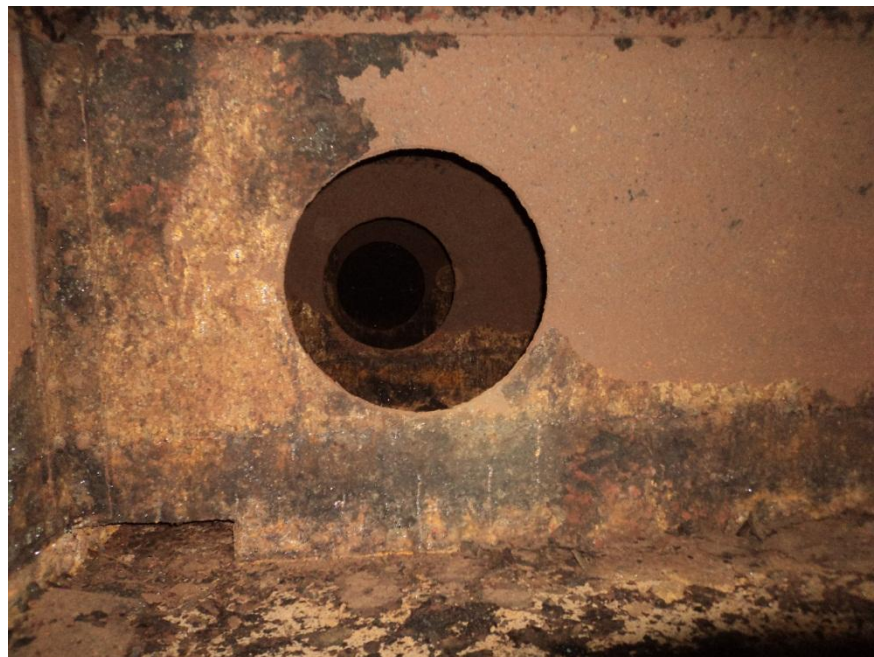
Figure 29: Typical Condition within B-3-2-W Tank

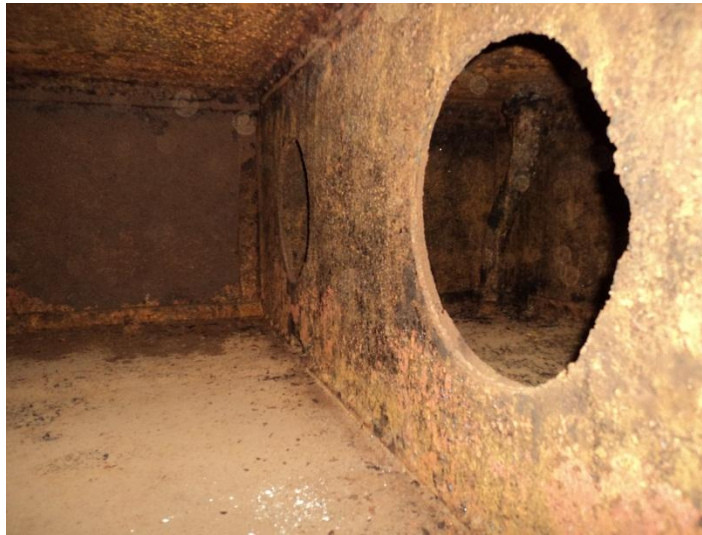
Not previously inspected under the Option 1 Survey, this tank space with four transverse frames and two longitudinal frames is directly under both boiler room fuel manifolds and miscellaneous components; tank components are in fair/good structural condition with no repairs required at this time. Both transverse and longitudinal support frames are intact with plate loss in areas averaging 30 – 40% with minimal deflection of steel plate. The floor of this tankage is heavily rusted/scaled with greater than 30 - 50% wastage, but with no standing water present. Forward bulkhead intact showing 30 - 40% plate loss and the aft bulkhead intact with 40- 50% plate loss with heavy rust/scale present. Vertical scantlings on both fore and aft and outboard bulkheads intact. Centerline keel plate shows plate loss of 40% in areas of deep pitting, but is not in need of repair at this time.

Figure 30: Typical Condition of Transverse Frames within B-3-1-W

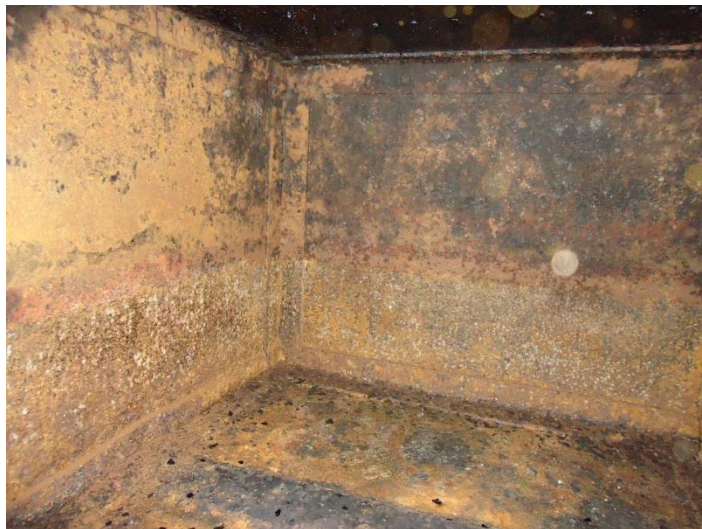
Figure 31: Forward Longitudinal Frame within B-3-1-W

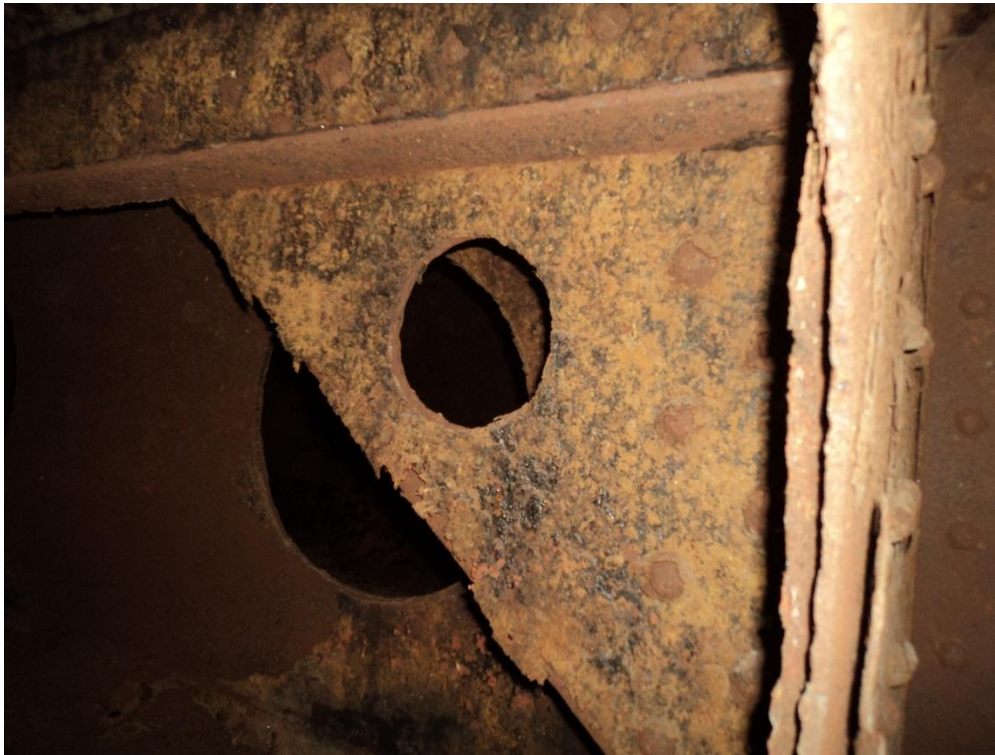
Figure 38: Typical Condition of Boiler Support within B-4-2-W

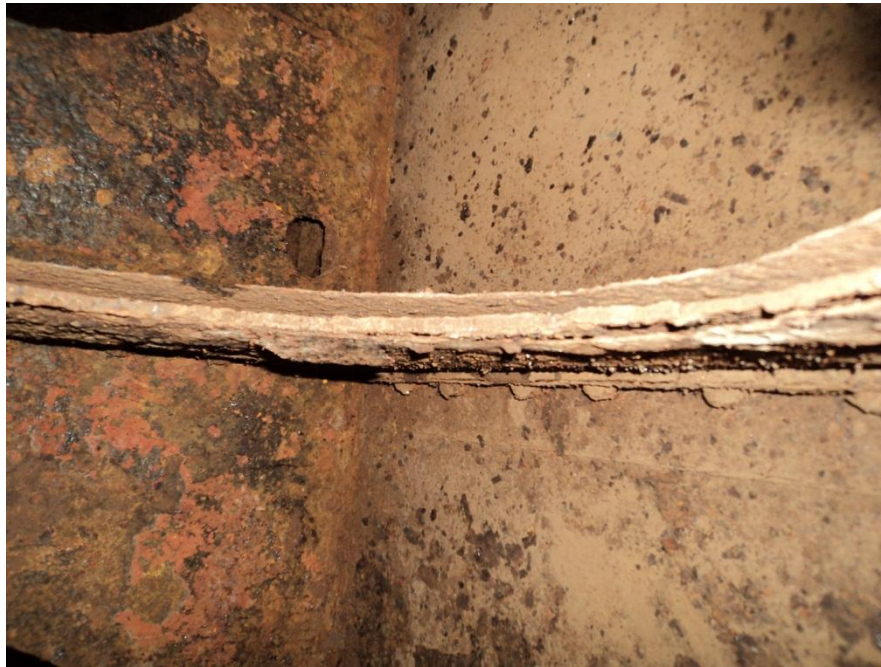
**Figure 39: Typical Condition of De-laminated and Holed Frames within B-4-2-W**

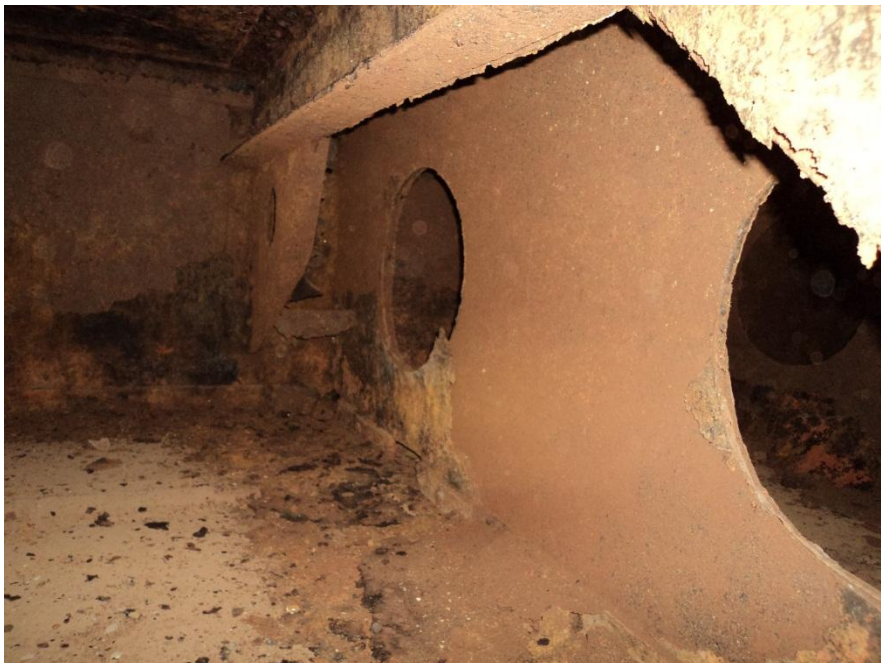
**Figure 40: Typical Condition within B-4-2-W**

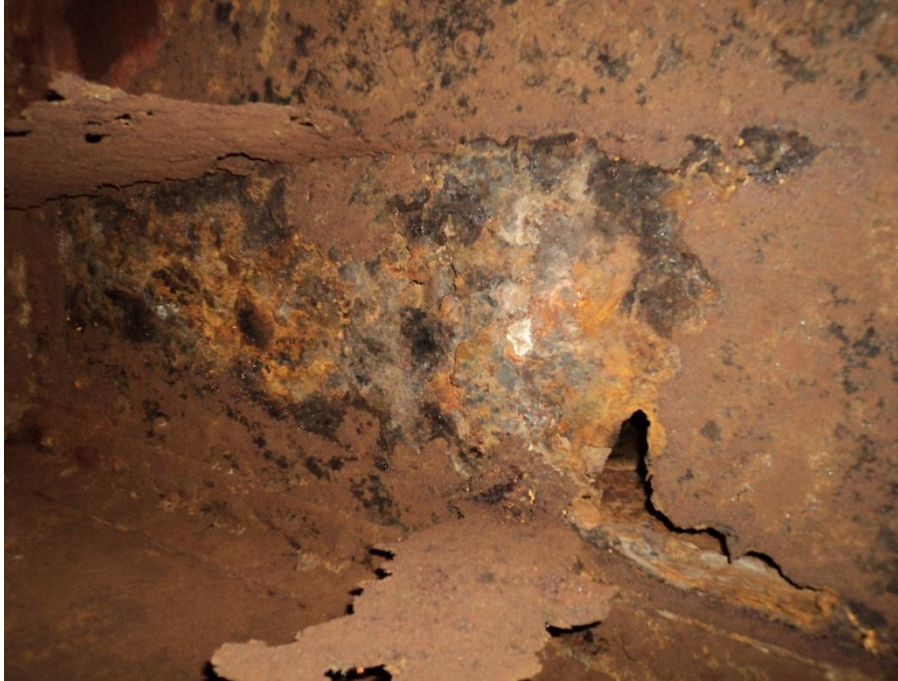
**Figure 41: Typical Condition with Holed Plating on Overhead within B-4-1-W**

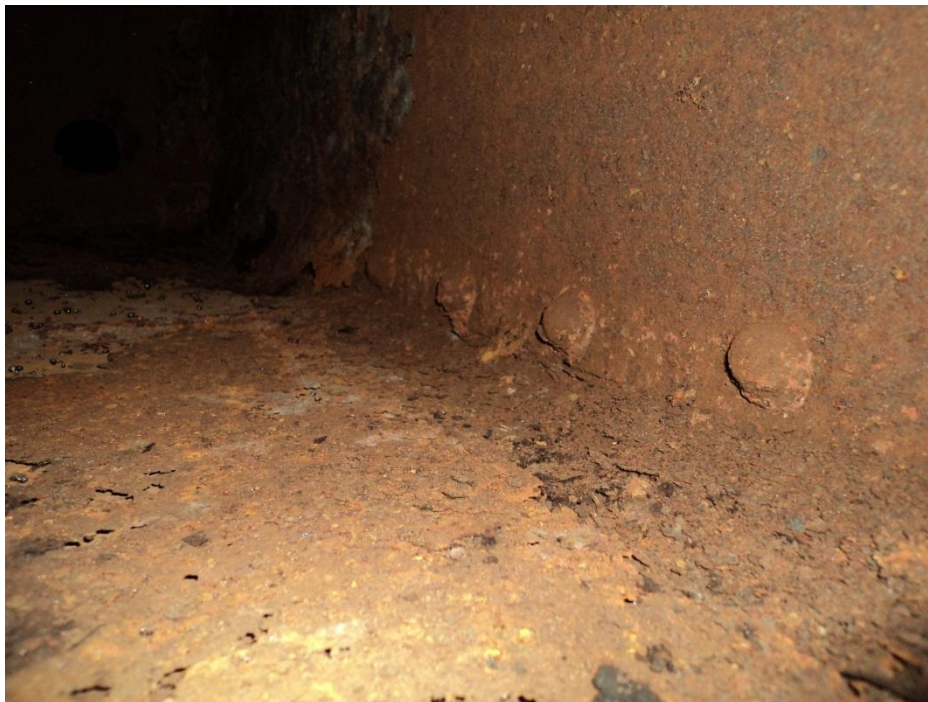
**Figure 42: Typical Condition within B-4-1-W**

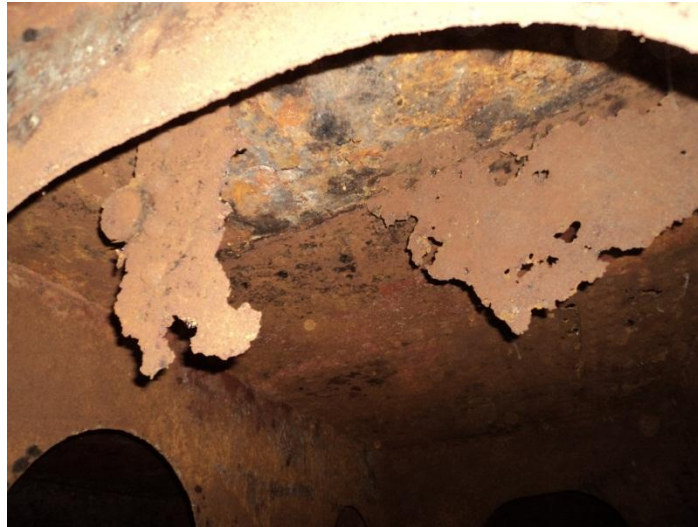
Not previously inspected under the Option 1 Survey, this tank space with four transverse frames and two longitudinal frames is directly under both boiler room fuel manifolds and miscellaneous components; tank components are in fair/good structural condition with no repairs required at this time. Both transverse and longitudinal support frames are intact with plate loss in areas averaging 30 – 40% with minimal deflection of steel plate. The floor of this tankage is heavily rusted/scaled with greater than 30 - 50% wastage, but with no standing water present. Forward bulkhead intact showing 30 - 40% plate loss and the aft bulkhead intact with 40- 50% plate loss with heavy rust/scale present. Vertical scantlings on both fore and aft and outboard bulkheads intact. Centerline keel plate shows plate loss of 40% in areas of deep pitting, but is not in need of repair at this time.

Figure 43: Typical Condition within B-4-4-W

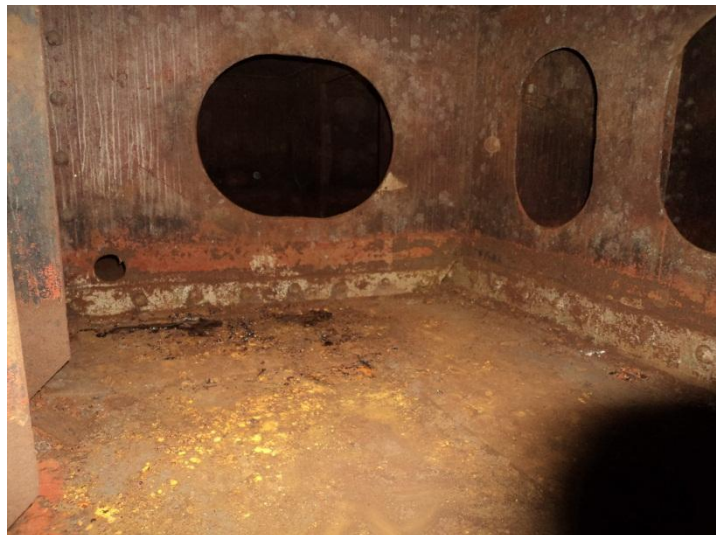
Figure 44: Typical Condition within B-4-4-W

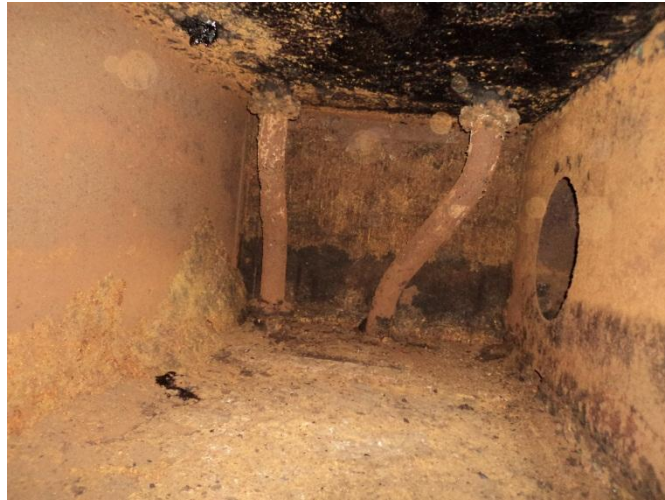
Not previously inspected under the Option 1 Survey, this tank space with four transverse frames and two longitudinal frames is directly under both boiler room fuel manifolds and miscellaneous components; tank components are in fair/good structural condition with no repairs required at this time. Both transverse and longitudinal support frames are intact with plate loss in areas averaging 30 – 40% with minimal deflection of steel plate. The floor of this tankage is heavily rusted/scaled with greater than 30 - 50% wastage, but with no standing water present. Forward bulkhead intact showing 30 - 40% plate loss and the aft bulkhead intact with 40- 50% plate loss with heavy rust/scale present. Vertical scantlings on both fore and aft and outboard bulkheads intact. Centerline keel plate shows plate loss of 40% in areas of deep pitting, but is not in need of repair at this time.

**Figure 45: Typical Condition of B-4-3-W**

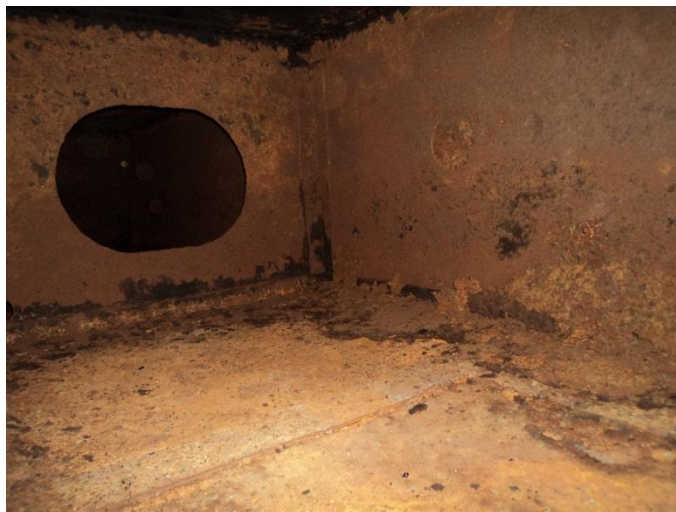
**Figure 46: Typical Condition of B-4-3-W**

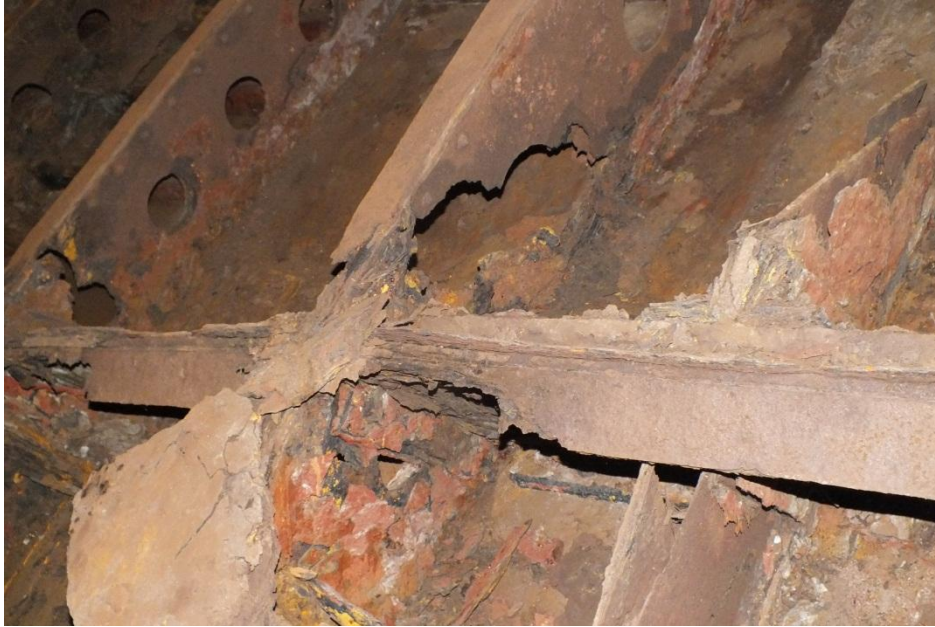
This trimming tank is a large open space with fore and aft bulkheads and main transverse frames and vertical steel stanchions supporting the overhead. Much of the support framing and all of the stanchions require replacement. The bulkheads, likewise, require replacement.

**Figure 62: Typical Main Transverse and Longitudinal Frame in D-12 Trimming Tank**

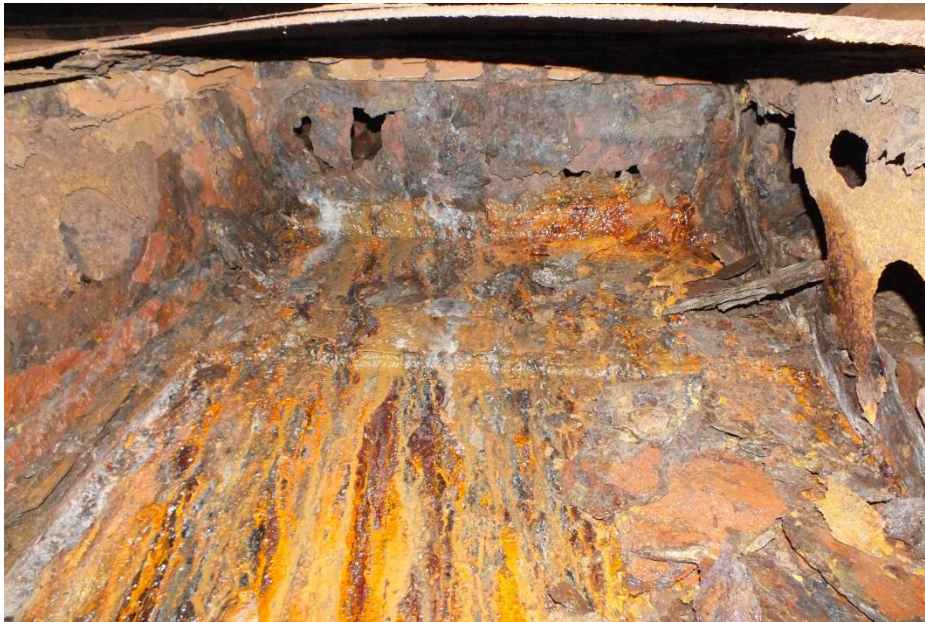
**Figure 63: Wasted Longitudinal and Transverse Frames to Starboard between Frame 122 – 124.  
Notice Seepage and Run-off from Leaking Shell Plating in D-12 Trimming Tank.**
